Removal and Restoration Agreement for Residential Removals Libby, Montana

Address of Removal: 1325 Airstrip Rd

Type of Remediation: Vermiculite-containing insulation removal from attic and exterior removal

Exterior Inspection Checklist (EIC)

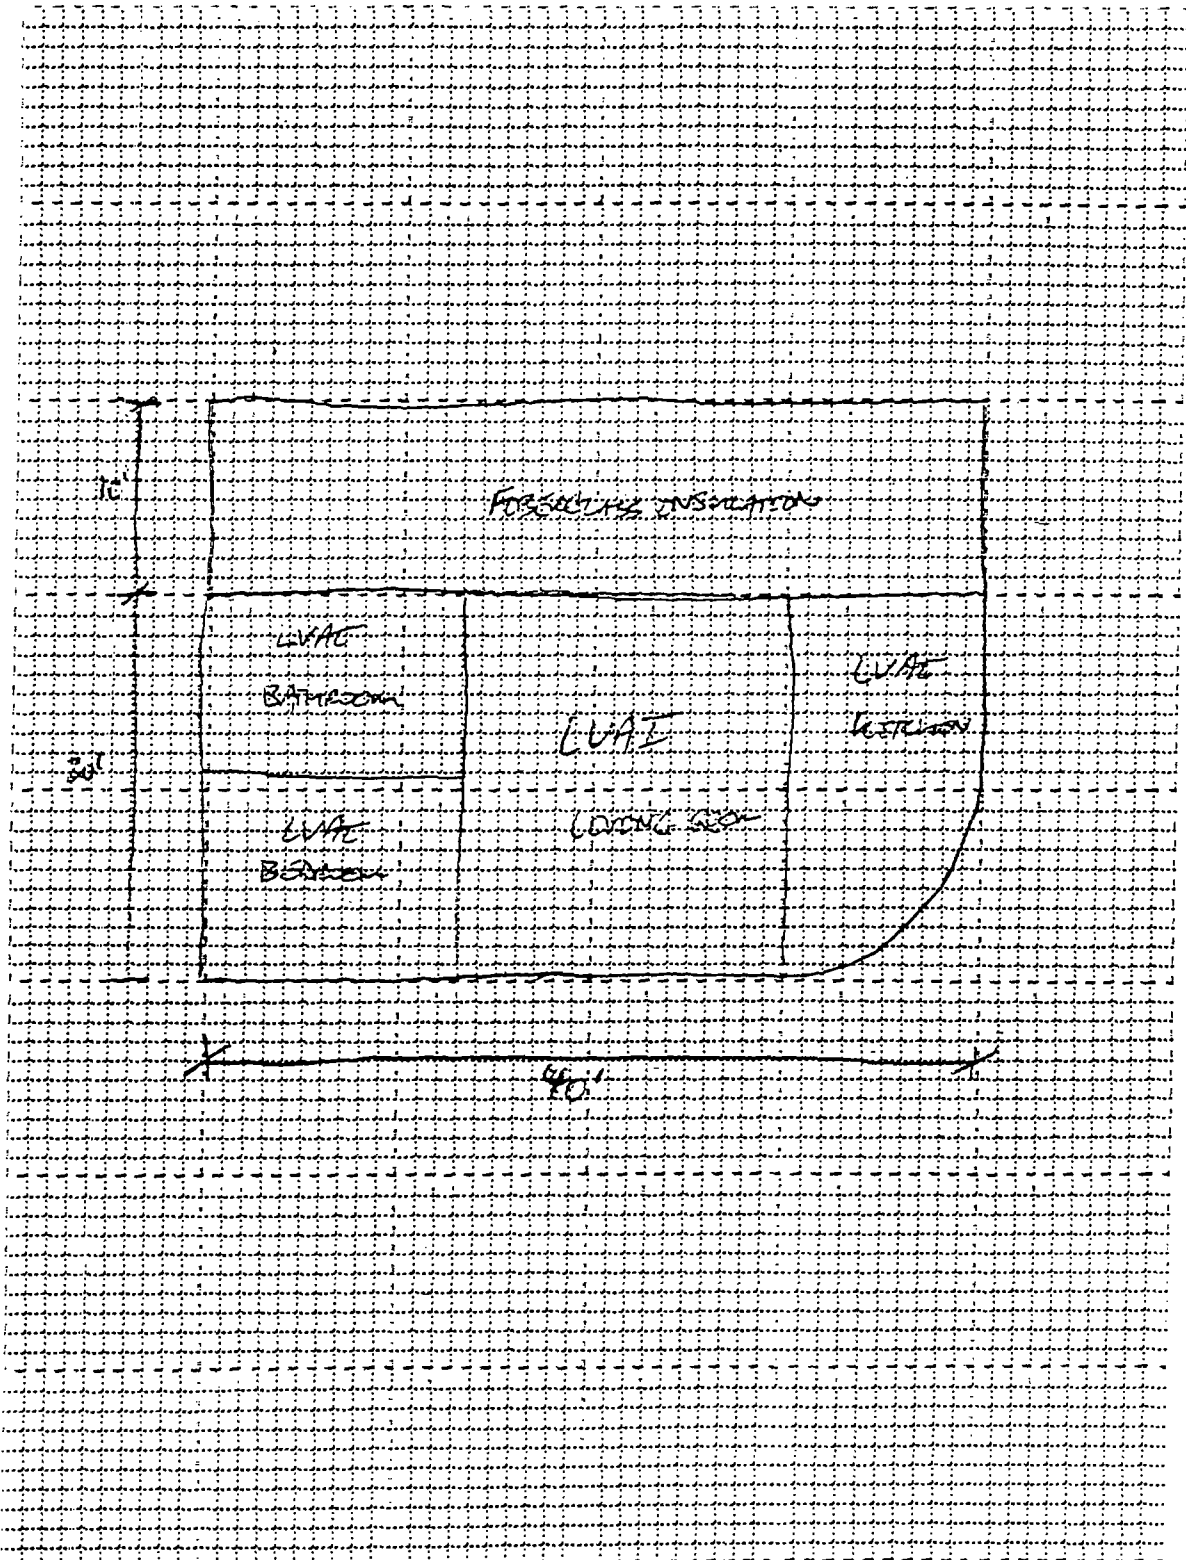
EC 000004

NOTE: ALL EXCAVATION LINES (---) EXTEND 3' BEYOND THE CONTAMINATED AREA BORDER

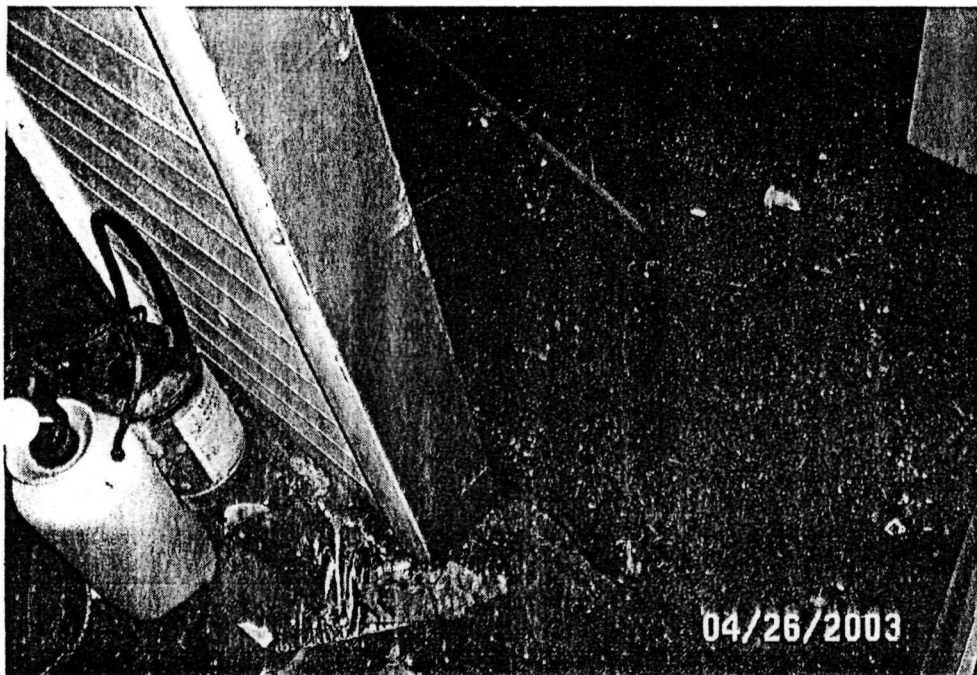
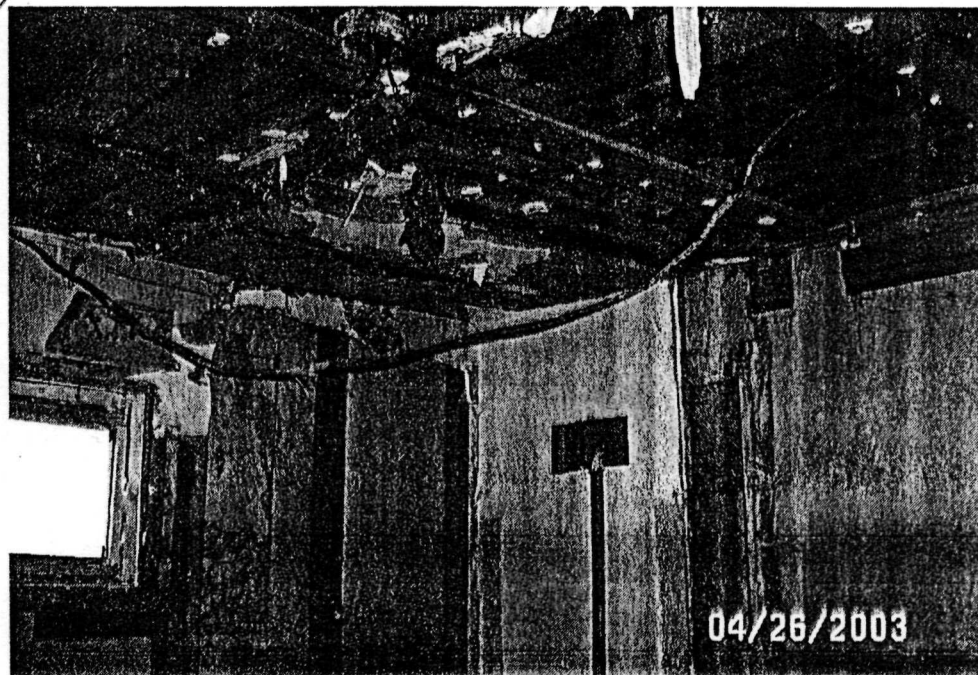
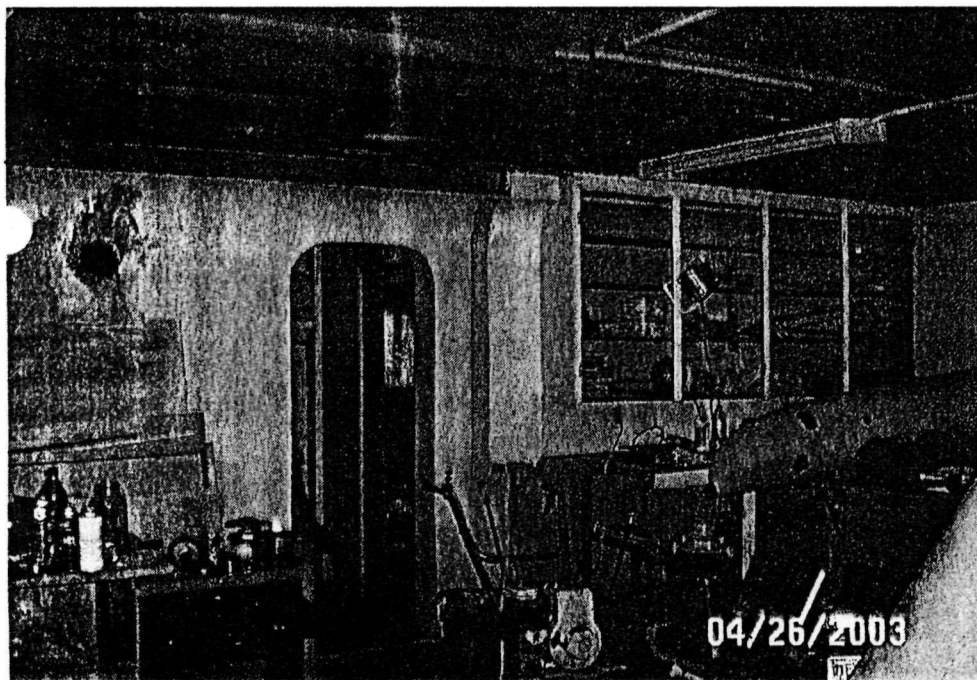
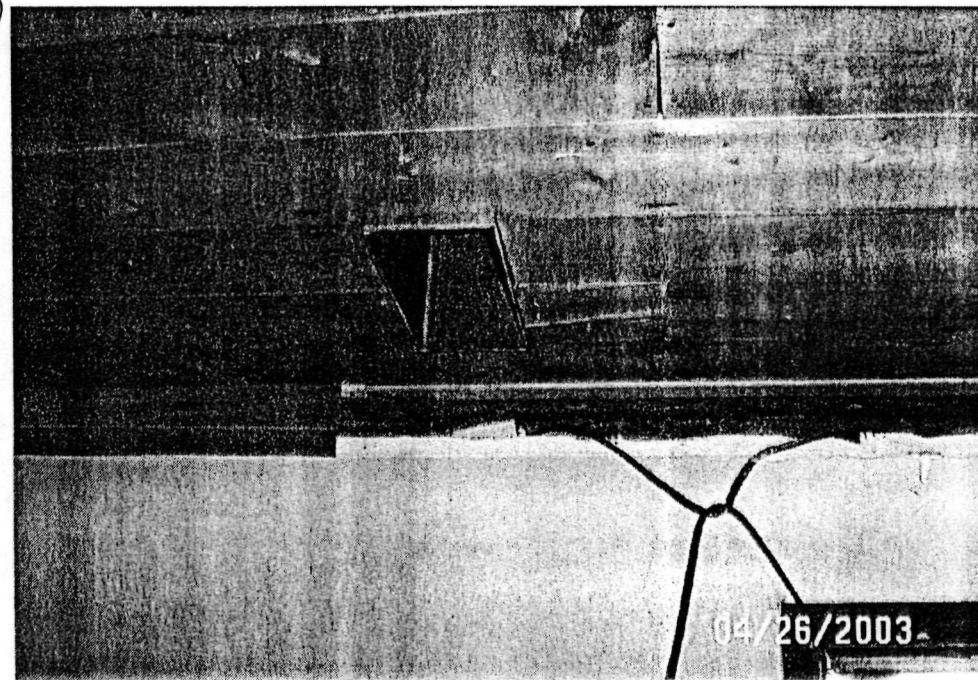
- ① Scattered VCI ON FLOOR
- ② Storage Items Tools etc. AND VCI present
- ③ Ceiling and walls missing
- ④ VCI coming out of ceiling

- VCI is observed within every room, wall, and in the crawlspace

Note: House in very
poor condition

VCI - in walls, ceiling,
Crawl Space, Floor.
